# Life Asset Extension for Flanged Connections

## Case Study

| Location | Nigeria – Bonga FPSO |

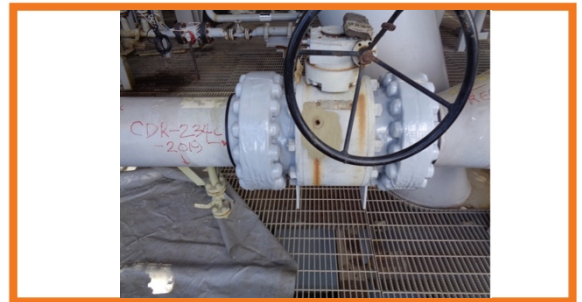
*Pictures of the substrates with Oxifree TM198 after job completion*

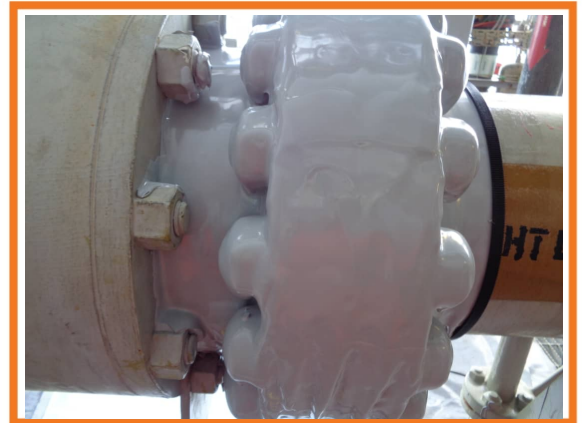
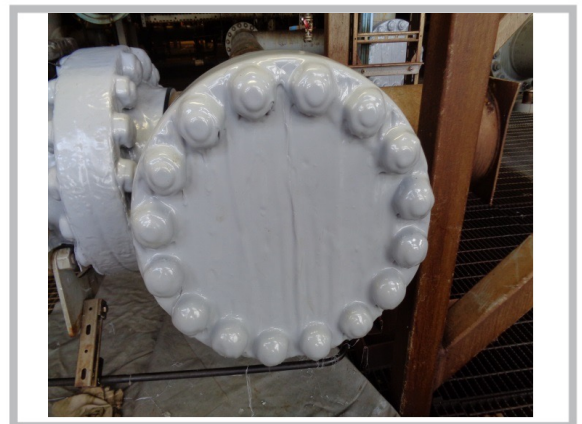
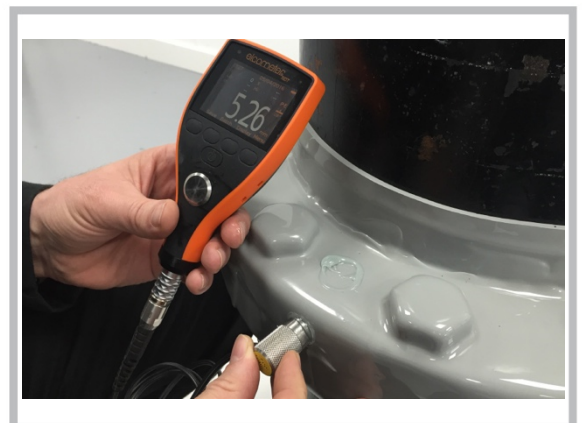
*Pictures of the substrates with Oxifree TM198 after job completion*
