## Case Study: Jack Up Housing Blocks & Tubing

## *Oxifree testing onboard Wind Discovery for Jack Up House Tubing and Blocks*

| Location | Esbjerg Harbour in Denmark |
| Date | January 2026 |

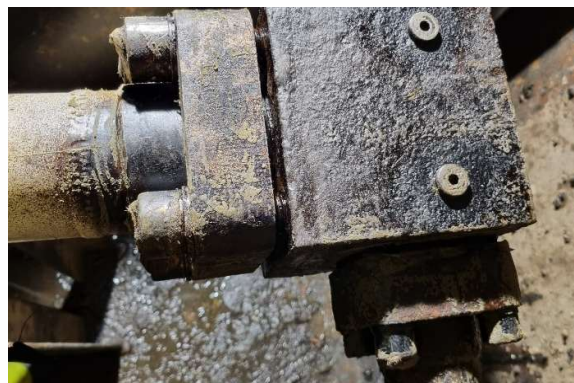
The trial was conducted in Esbjerg harbour in Denmark in January 2026. The jack up housing is occasionally submerged, so the tubes and blocks corrode heavily. The client's current solution is changing the tubing and blocks every 2-3 years.

*New Corroded Hydraulic Blocks & Tubing*

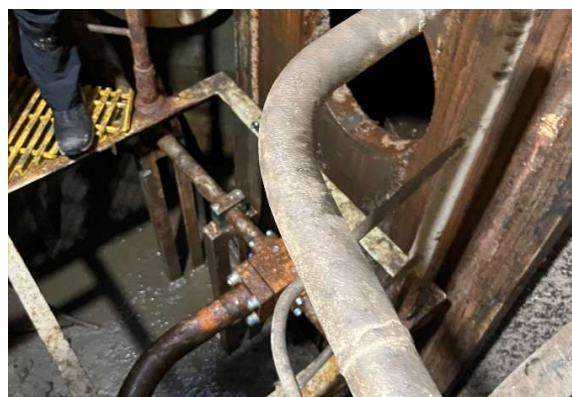
*Different location but old corroded block*

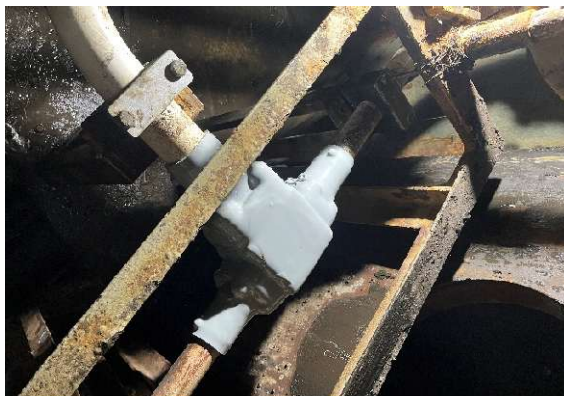
*Block coated with Oxifree TM198*

Upon arrival, the team removed the anti-corrosion wax tape from the hydraulic block. After that, there was minimal surface preparation and the coating could begin. The temperature was below zero degrees Celsius, so the coating cooled faster and was done in less than 2.5 hours. Once cooled, the Oxitape application could start. Approx. 20 meters of Oxitape was required to completely cover the Oxifree TM198.

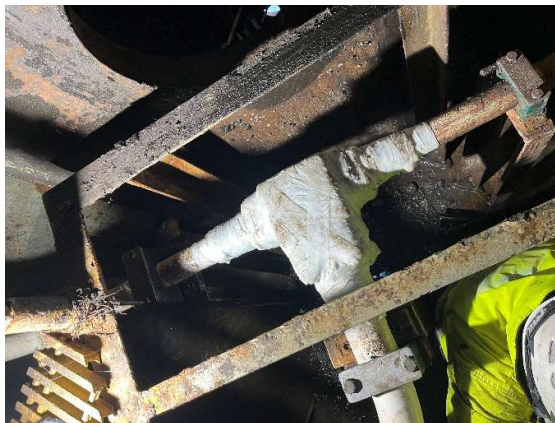
*Block covered with Oxitape above TM198*

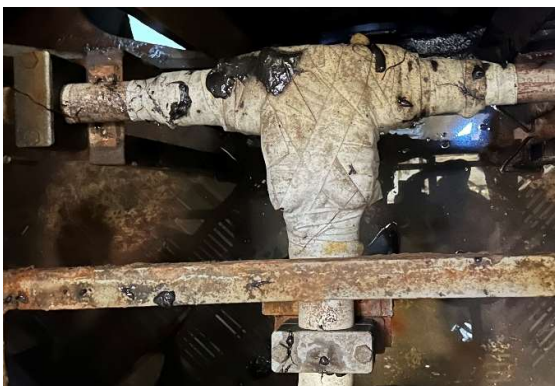
*Coated block after 3 months*

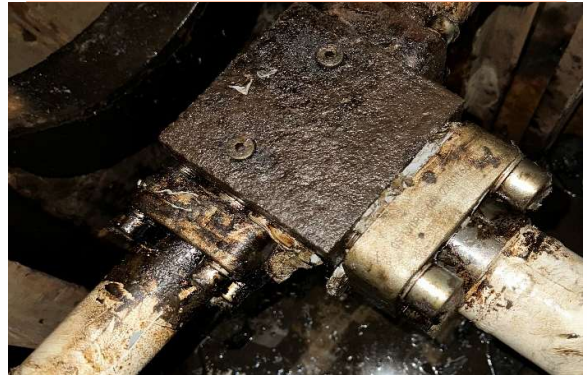
As you can see, there is an oily surface on the assets created by the TM198 corrosion inhibitor, but no further corrosion has taken place. The assets are in the same condition as they were prior to the application of Oxifree TM198 & Oxitape.

*Hydraulic block after Oxifree removal*

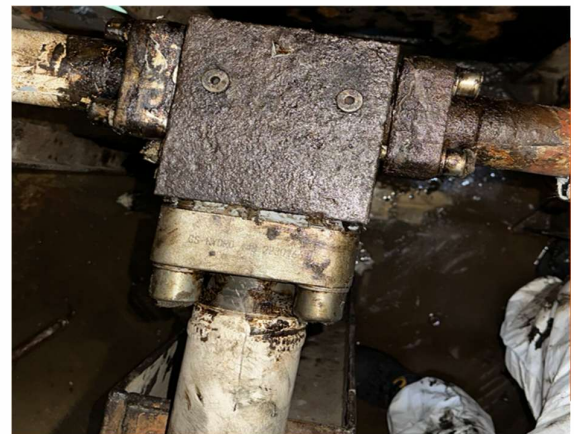
*Another angle of block after removal of Oxifree*
