## Transformer Oil Leak Case Study

## Transformer oil leak solution

| Location | Lunanhead |
| Substrate Type | Transformer |

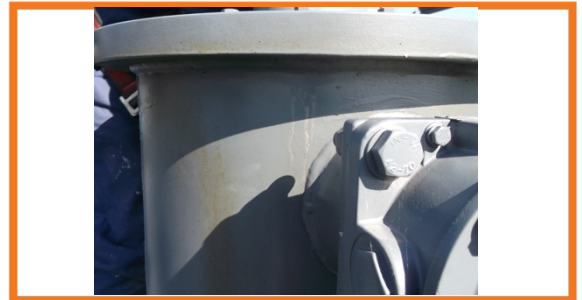
SSE contacted Oxifree as they had an oil leak on a transformer at a substation in Lunanhead.

Before

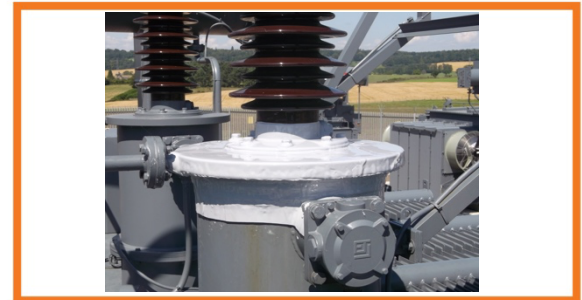
Application of repair bandage

The agreed solution was for the client to firstly apply a repair putty to the leaking area, then apply a repair wrap and finally Oxifree to apply two layers of Oxifree TM198 to give an overall thickness of approximately approx. 4mm.

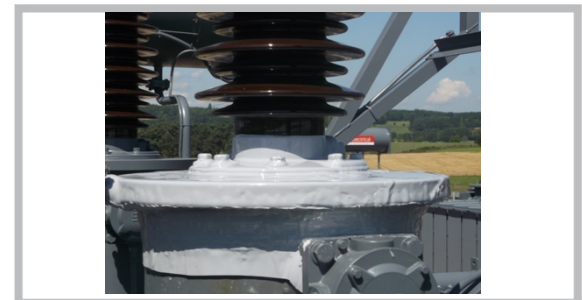
Completed

The project was completed, the oil leak was stopped and Oxifree have not had to return to this site, so the project was deemed a success.
