# Oxifree Case Study Chemical Sector

**Location:** Industrial Complex, Bahia (BA), Brazil

**Period:** 26/03/08 to 03/04/08 (9 days in the plant)

To apply Oxifree polymeric resin coating for corrosion protection, to improve safety and reduce ongoing costs. The application of Oxifree TM198 will show its ability to seal against atmospheric corrosion under the extreme operating conditions in which the valves and flanges are subjected.

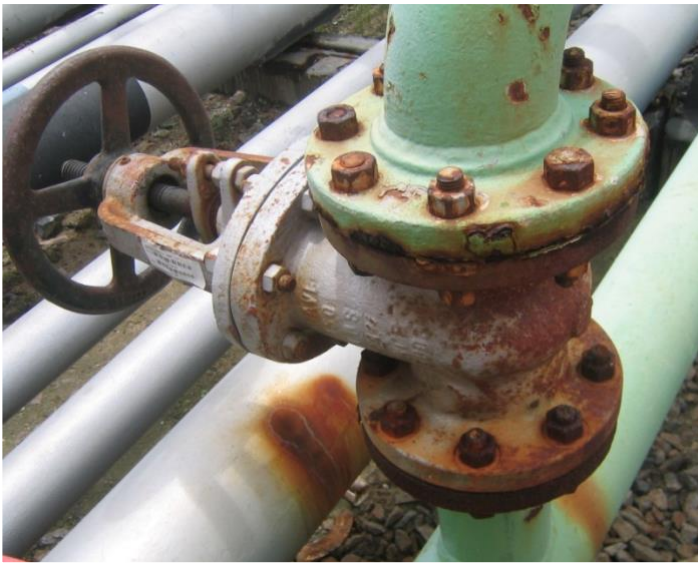
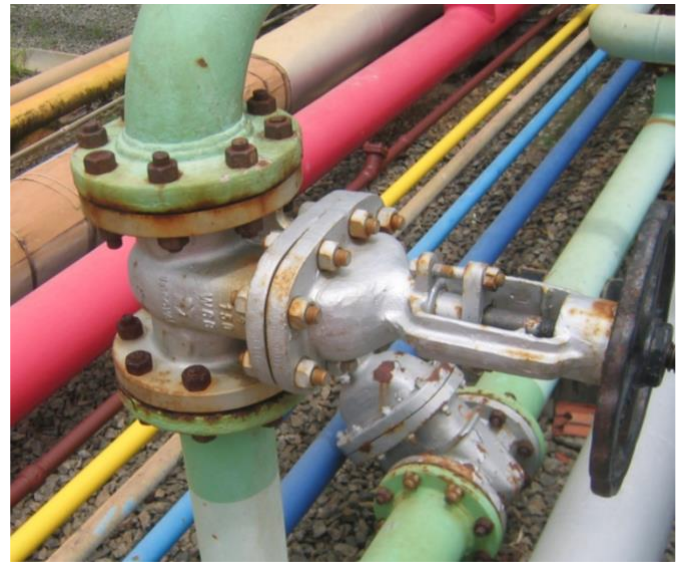
It has been found that there are pockets of corrosion in an advanced stage due to chemical spills from the operation of the Tower. Once the corrosion cell is formed the trend is that the damage accelerates due to the aggressiveness of the plants products combined with the corrosive action of the atmosphere and moisture in the air. Please see examples below:

Gate valves with varying corrosion damage to almost all surfaces

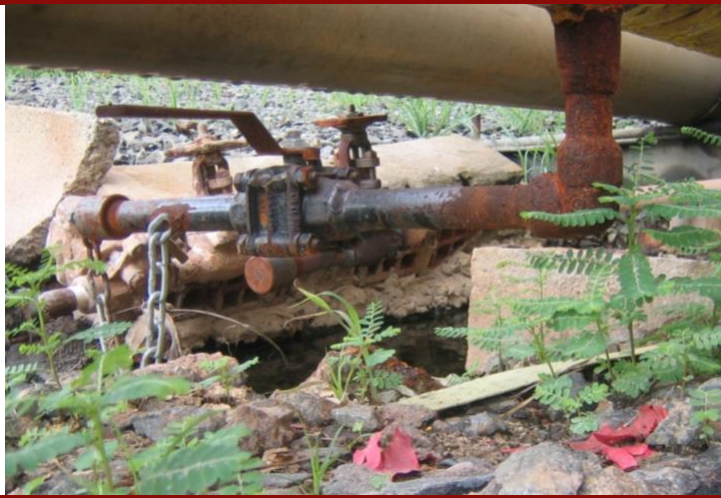
Ball valve with corrosion at its most critical on the elbow connector

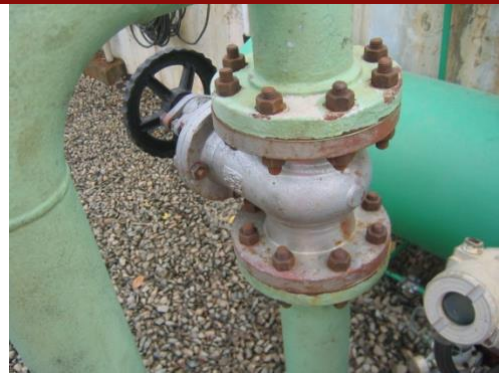
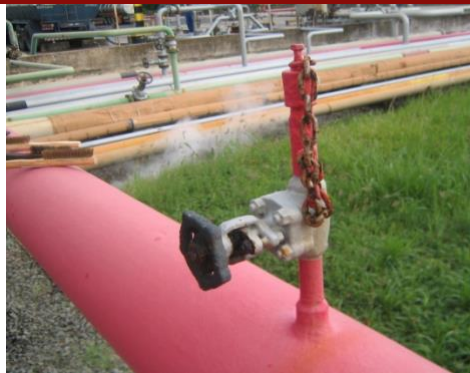
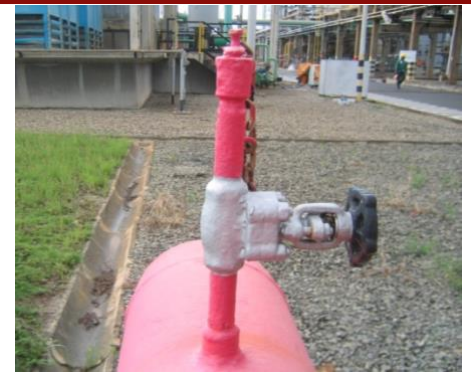
The surface preparation was completed by the use of a steel brush as well as 36 and 50 grain sandpaper. This enabled the removal of oxides and contaminants deposited on the components before the application of Oxifree.

The application of Oxifree material was completed despite adverse climatic factors of rainfall and high wind speeds. The situation can easily be overcome with the use of a work tent or other suitable habitat.

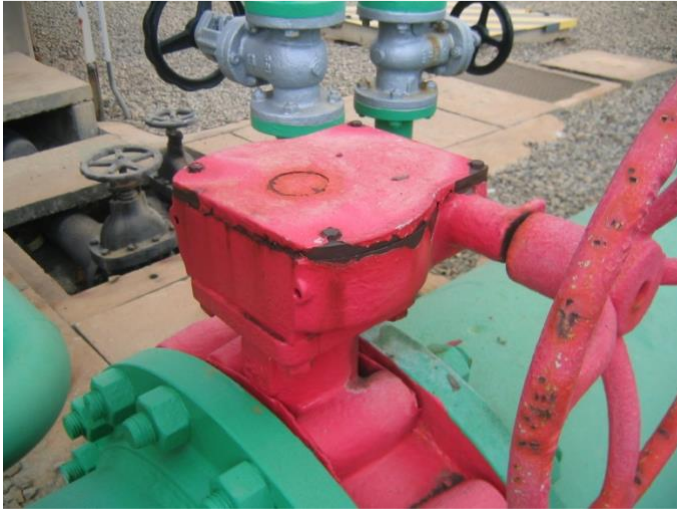
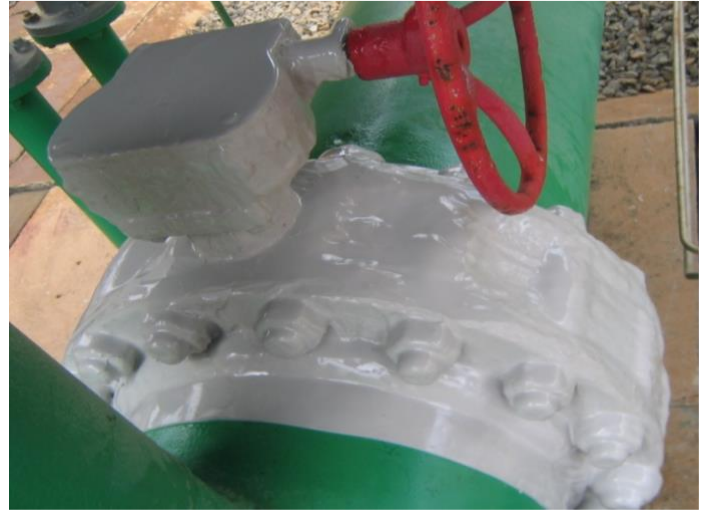
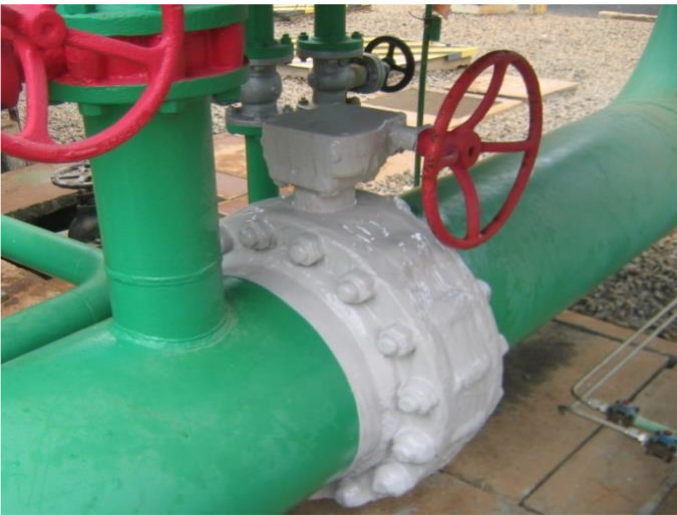
### Before and After the application examples:

The mechanical components are sealed against a likely increase in the atmospheric corrosion process due to the presence of sulphur oxides. The reaction with moisture in the air leads to the formation of compounds such as aggressive  $\text{H}_2\text{SO}_4$ . This chemical process is known as etching and causes a decrease in service life of valves and pipe fittings.

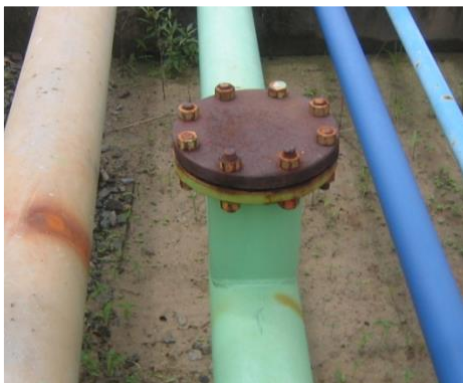
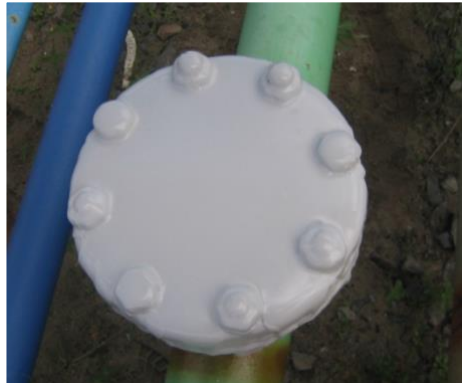
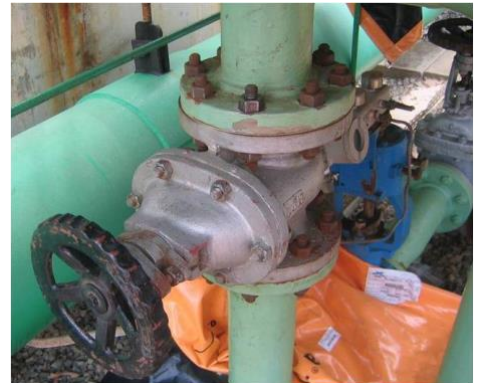
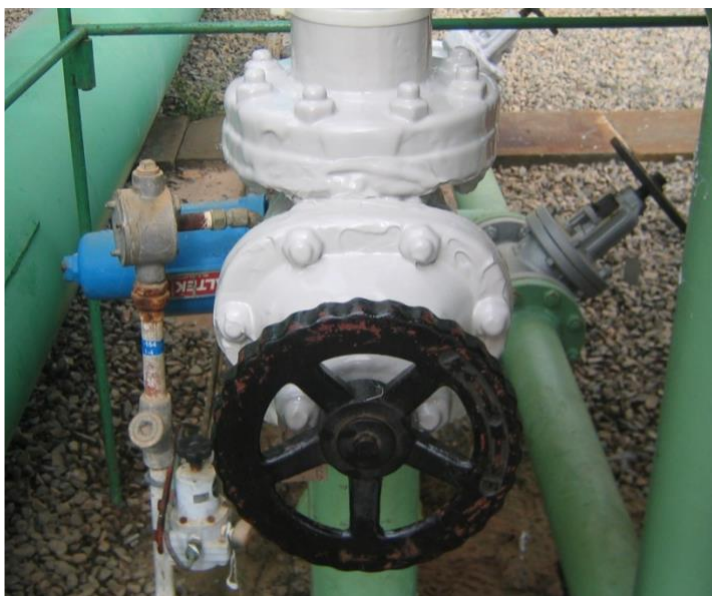
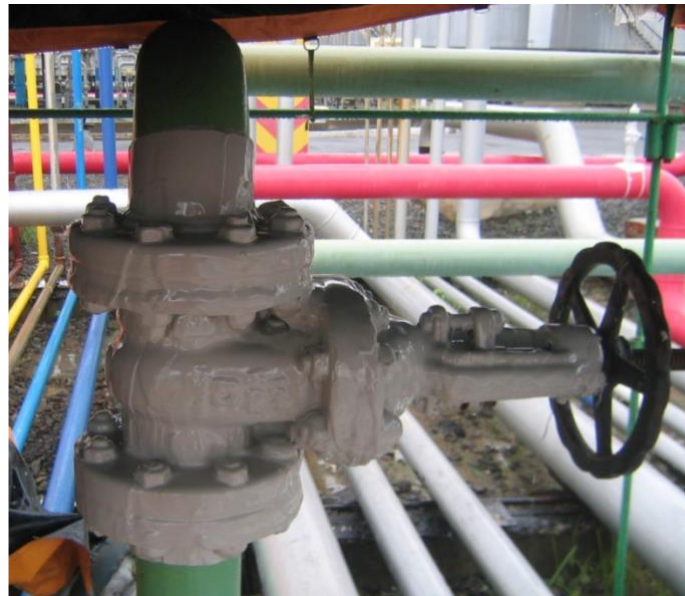
### Before and After the application on flange heads and globe valves:

Protection of the substrate surface is assured with the use of Oxifree however complicated the shape as is evidenced below.
