## Flange / Coupling Corrosion Protection Case Study

## Flange / Coupling Corrosion Protection

| Location | Upper Bittell Reservoir |

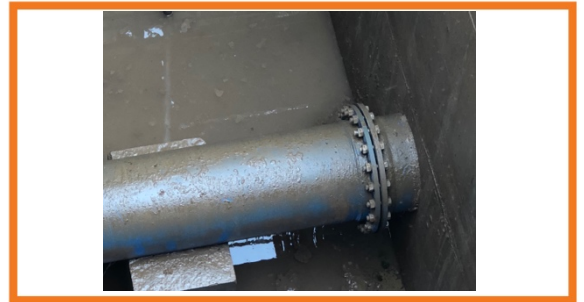
*Flanges prior to clean & application*

The lower pipework was cleaned of mud and dried to allow the application of Oxifree TM198 to both the flange assembly & the pipe coupling. Between 4-6mm of Oxifree TM198 was applied. On the top valve assembly, the upper flanges were coated above and below with the lower flange being coated above only as the underside was sealed within a steel box.

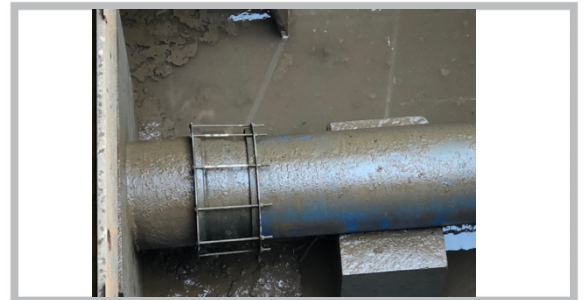
*Pipe coupling prior to clean and application*

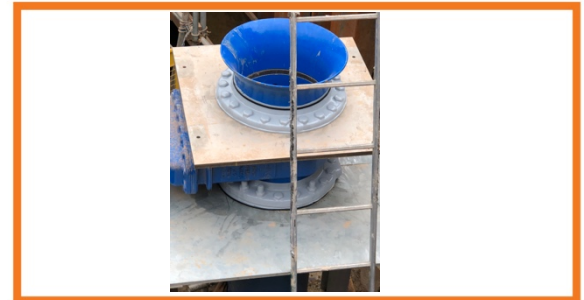
*After TM198 application*

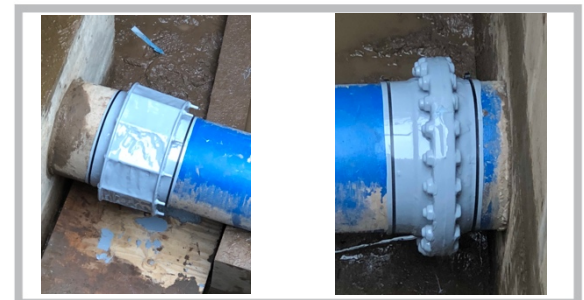
*After TM198 application*
