## Preservation of gasoline transportation pipes

### Case Study

## Pipeline protection project in an onshore tanking terminal.

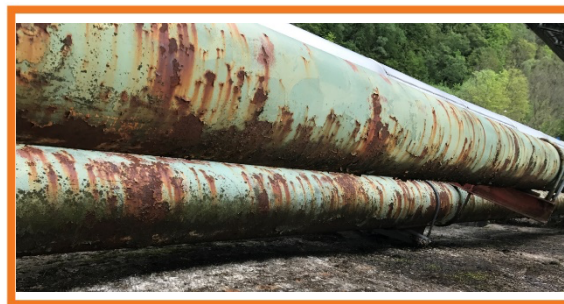
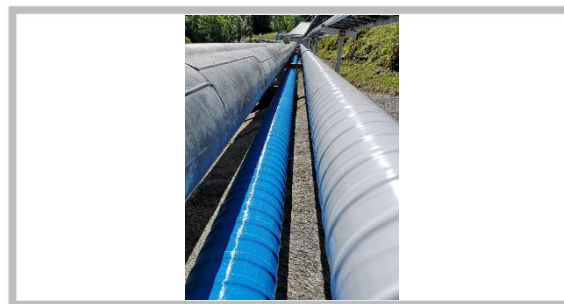
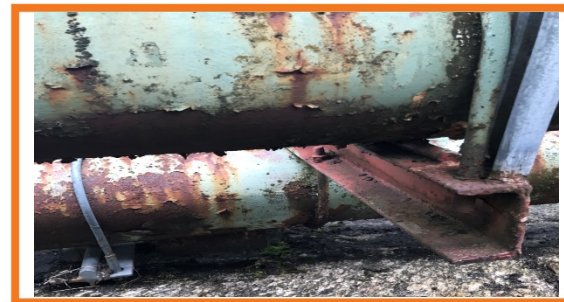
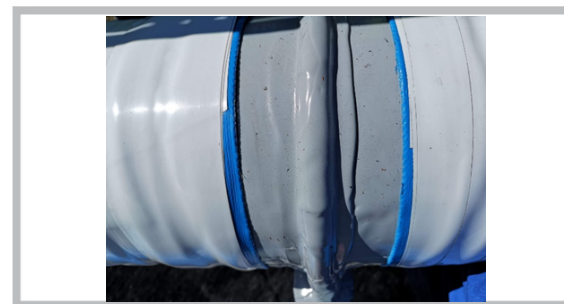
The pipelines have been suffering in a salt and humid environment for many years, leading to visible and partly severe corrosion. The pipes are approximately 10" and have clamps and supports approx. every 8 meters.

*The photos below clearly show the degradation to the pipelines prior to application of TM198*

First, the pipelines were cleaned to approximately ST-2. This was done with Valhall's UltraGel, a green and environmentally friendly alternative to sandblasting when removing corrosion. The pipes were high pressure washed to remove loose particles, then the Ultragel was applied before the pipes were high pressure washed again after approximately 24hrs. This additional cleaning ensured any loose debris was removed.

Once dry, the flanges, pipe supports and pipe clamps were coated Oxifree TM198 using the Polymelt 50 Atex applicator. This machine is suitable for use in hazardous environments.

The pipe bodies were then wrapped with viscoelastic coating as an inner layer before a PE outer wrap was applied. The viscoelastic coating is overlapping the Oxifree TM198 with 1-2 cm.

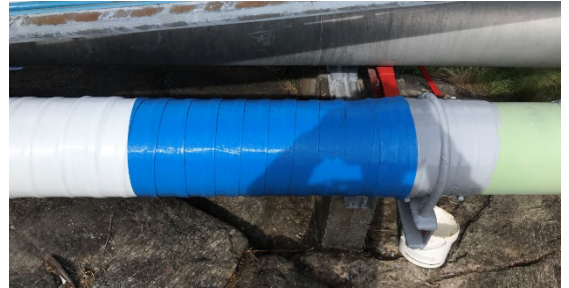
*Here you can see the finished applications with the two products combined.*

Applying Oxifree TM198 on the flanges, pipe supports and clamps and viscoelastic coating on the pipe body, represents a long lasting, cost efficient and environmentally friendly solution. The pipes are now protected with market leading methods complementing each other and should be ready to operate for many years in the harsh environment where it's situated.

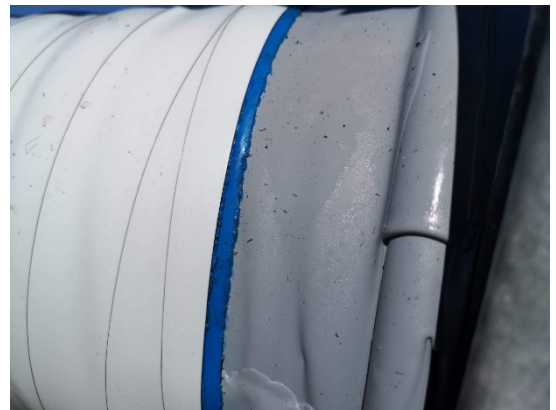
An inspection of the viscoelastic coating will be carried out in due course. Oxifree TM198 can be inspected at any time by either NDT using digital/UT inspection tools or by simply cutting away a small area and refilling it.
