# Peak Gas Installation – Flange Protection Case Study

## Oxifree Flange Protection

| Location | The Netherlands |
| Local Environment | Onshore Gas Storage |

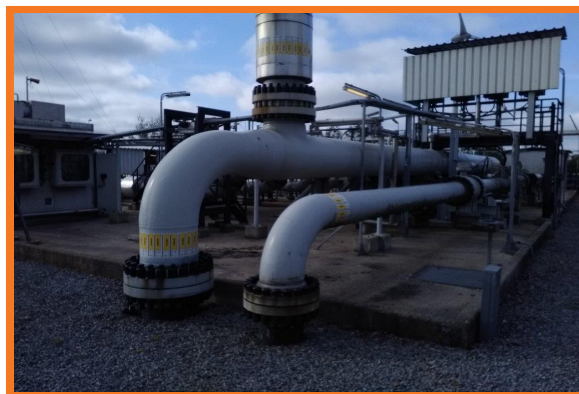
*Before*

Minimal surface preparation is required with the application of TM198, bolt caps were removed, and any loose surface was simply brushed away with a wire brush before coating.

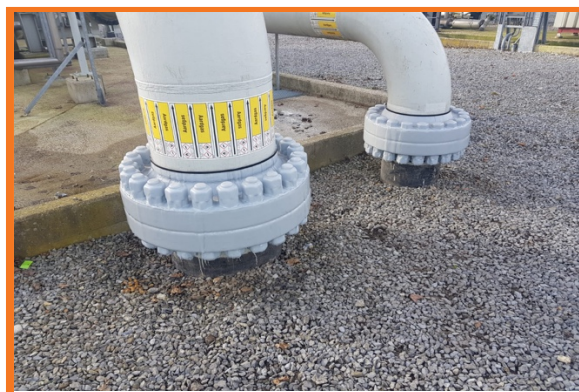
*After Oxifree Application*

The application of TM198 will extend the life of these assets and protect them from the harsh environment they are exposed to. The material can easily be removed for inspection and simply refilled.

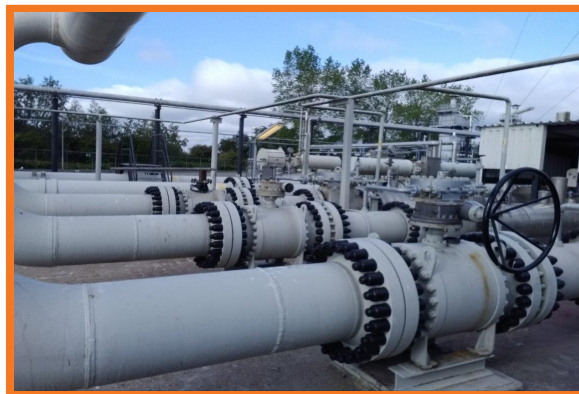
*Before*

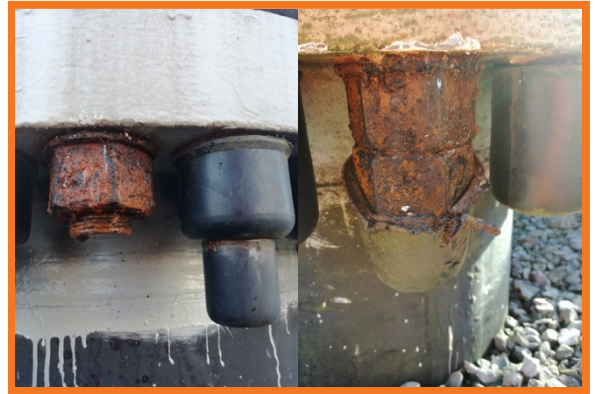
PGI were experiencing significant corrosion problems on the bolts on the flanges due to the failure of the bolt caps currently installed for protection.

*Failure of bolt caps*

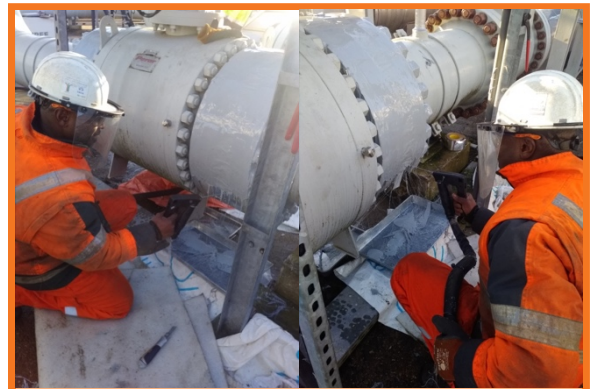
*During application*

2 x Polymelt 50 machines were used for this workscope.
