## Flange & Valve Protection Trial

### Boulby Potash Mine

#### Case Study

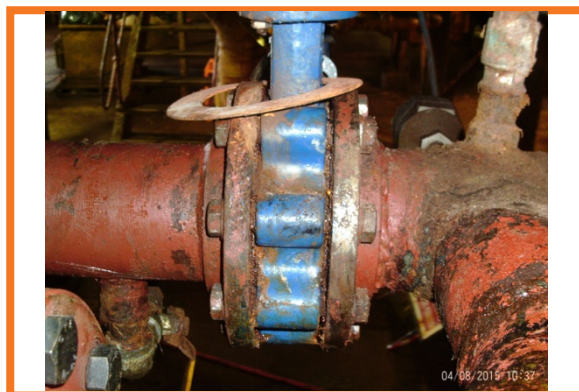
*Flanges & Valve Prior To Coating*

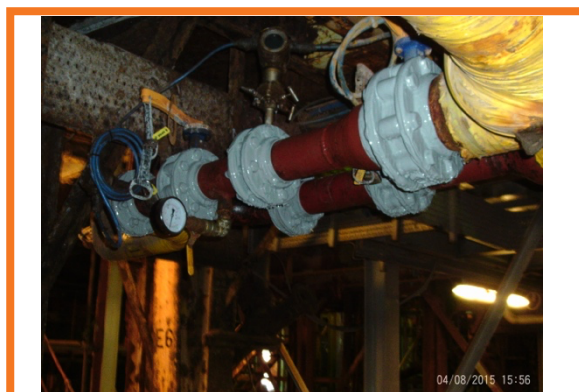
*Flanges/Valves - Oxifree*

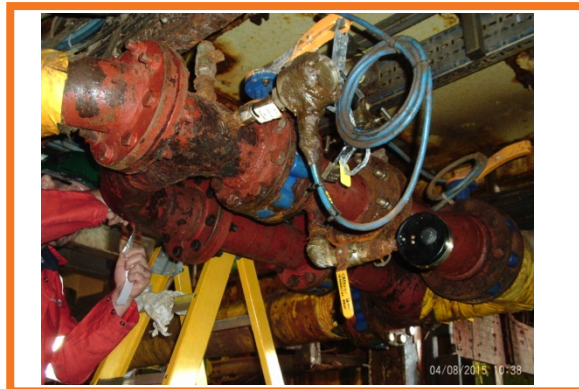
*Flanges & Valve Prior To Coating*

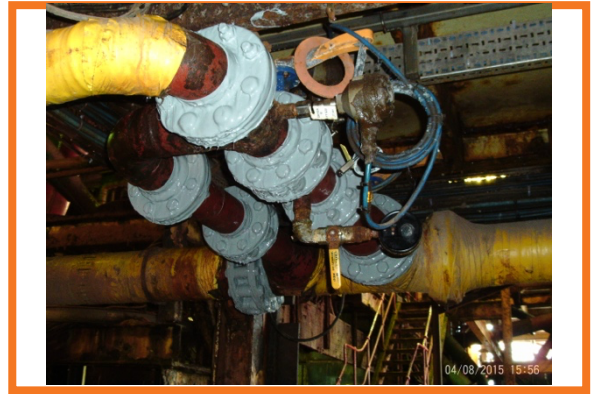
*Flanges/Valves - Oxifree*

Oxifree application technicians completed the project in 3 days. The Oxifree TM198 was applied directly onto the flange/valve assemblies after a quick clean with a degreaser.

The application was carried out using the Oxifree Polymelt 50 application machine (situated on the floor) with a 15m hose.

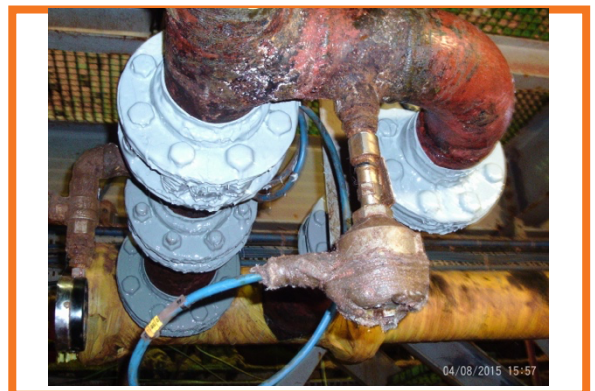
*Flanges/Valves - Oxifree*

A 4mm coat was applied to all areas. The coating, as approved by the client, will ensure the flanges/valves are protected for 10 years. No sandblasting required. In the future, the material is easy to remove for inspection. The anti-corrosion oil also acts as a penetrating oil for any existing corrosion.

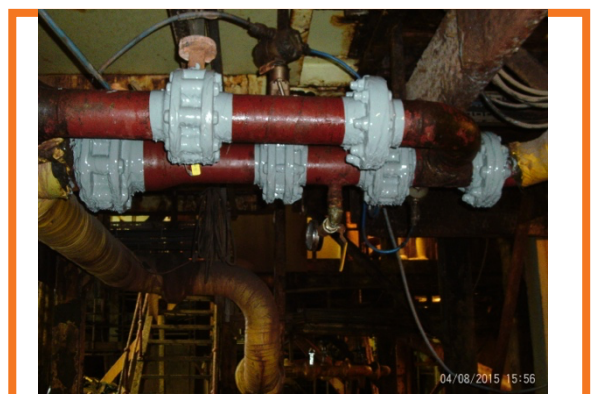
*Flanges/Valves - Oxifree*

Discussions with client at the end of 2022, confirmed that the material had been removed in late 2021 due to change in plant configuration. Client confirmed that no further corrosion had taken place and the TM198 material had stood up well within the potash environment.
