## Valve Corrosion Protection Case Study

## Valve Corrosion Protection

| Location | Denton Reservoir |
| Substrate Type | Gate Valve |

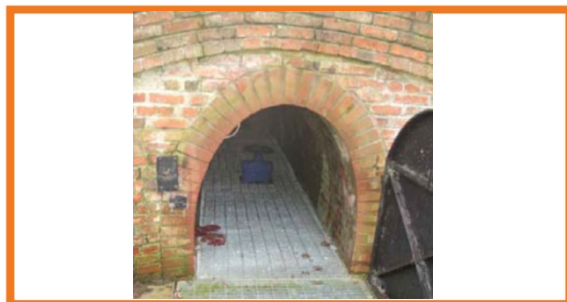
The project was considered a 'below ground' exercise as the tunnel in which the valve was situated was approximately 7 meters from the opening with height clearance of 1.6m. The tunnel required draining and removal of safety and security grating to gain access. The project was undertaken using the Polymelt 50 unit with a 15m hose and 2 trained technicians

Access Tunnel

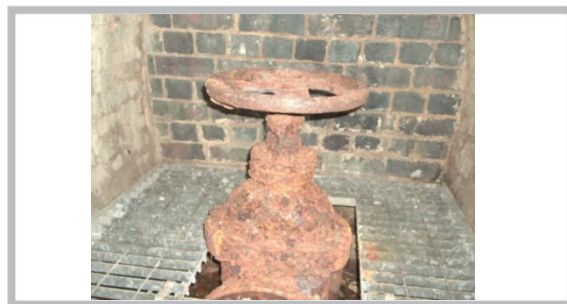
CPC Civils were tasked by the Canal & Rivers Trust for the replacement of the drain pipe from Denton Reservoir to feed the local amenities. The scope involved replacement of 200mm pipe run and a valve assembly. Unfortunately the original pipe and valve that protruded from the reservoir wall showed signs of heavy corrosion and deterioration and needed to be operational should the flow require arresting.

Gate Valve Before Application

The valve (1000mm tall) and pipework (1100mm length) were cleaned of loose debris, the area laid with tarpaulin to collect any runoff and the valve fully opened and locked, as per the Task Based Method Statement. A coating of 4-6mm of Oxifree TM198 was applied in a time frame of 2.5 hours. Upon departure, the grating was completely replaced and the area locked and sealed to prevent unauthorized access.

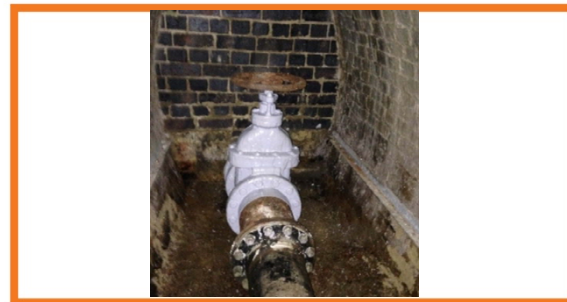
After TM198 application

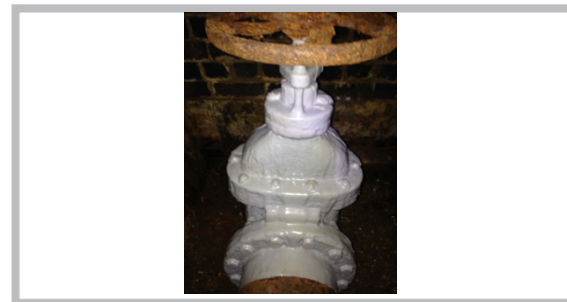
Completed
