## Crankshaft trial with Kinder Morgan Case Study

## Coating of crankshafts for trial in a outside exposed environment

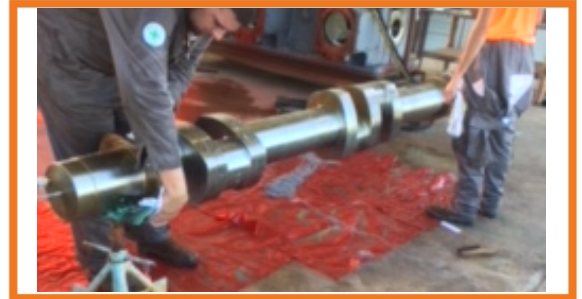
*The crankshafts were brought into the workshop to be coated.*

The machined shafts were inspected to ensure they were free of any oxidation and cleaned of loose dust and debris prior to application.

The Polymelt 50 machine was then used for application and a coating of 4mm applied.

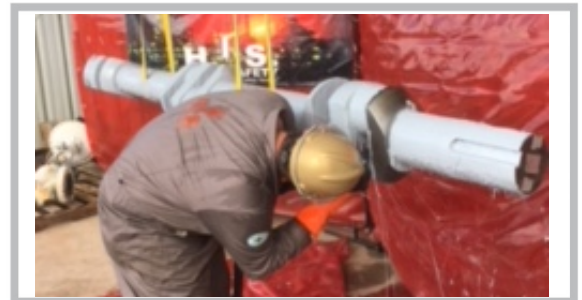
After

The Oxifree TM198 coating was applied to the entire crankshaft to protect from any corrosion to the machined surfaces.

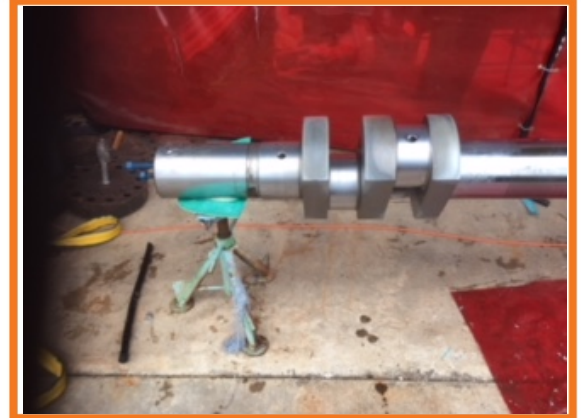
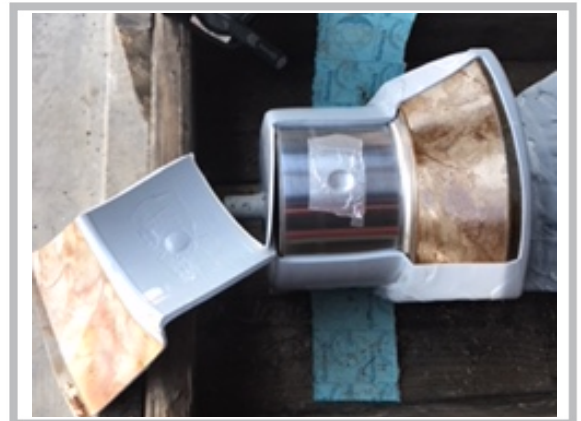
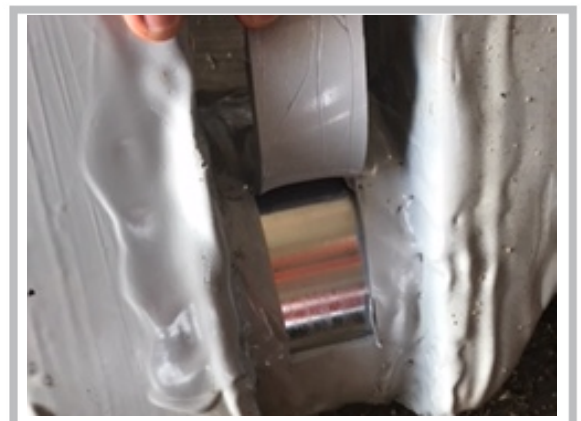
*Upon removal of TM198 the protection is clearly seen, the surfaces were free of corrosion.*

In June 2018 the coatings were removed from the crankshafts and the metal was found to be in perfect condition.

HIS were invited to the removal of the TM198 and as the photographs show the machine shaft was 100% free of corrosion.
