## Pipe Clamp Corrosion Protection – Gas Facility

### Case Study

## Corrosion Prevention On Pipe Clamps

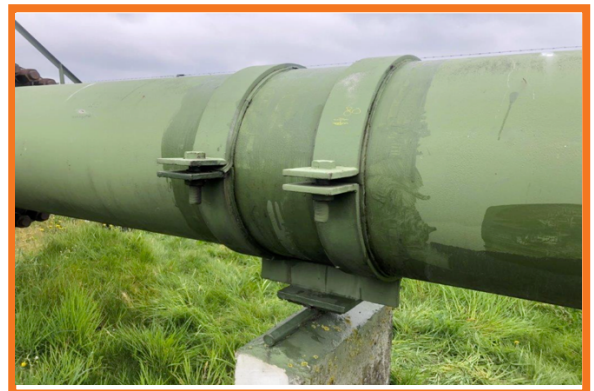
*Pipe Clamp Assembly prior to Oxifree*

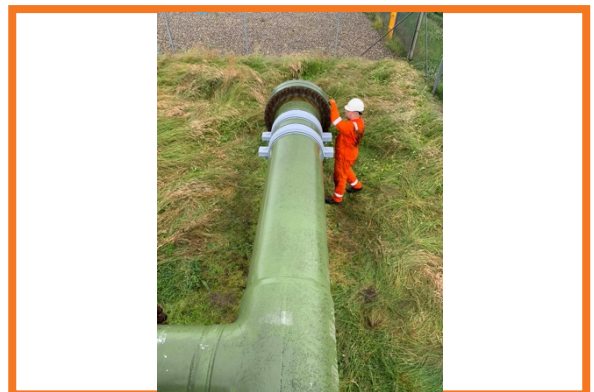
*Pipe Clamp Assembly Encapsulated by Oxifree TM198*

The Oxifree TM198 material was applied over the entire clamp, including the bolts and the steel support on the underside.

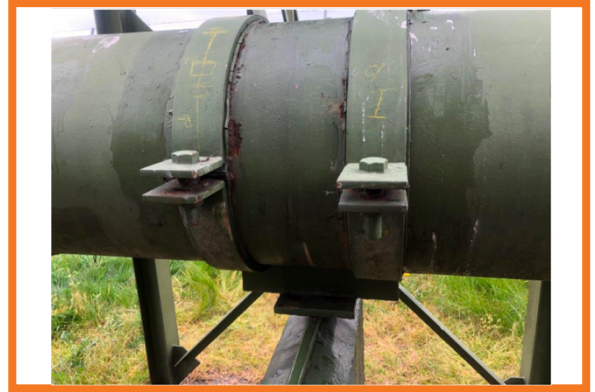
*Pipe Clamp Assembly prior to Oxifree*

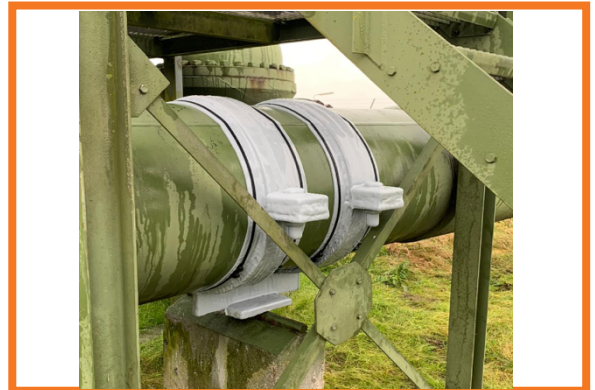
*Pipe Clamp Assembly Encapsulated by Oxifree TM198*

TM198 was applied directly onto the coupling assemblies. The application was carried out using the Oxifree Polymelt 50 A-I (Atex & IECEx) application machine with a 15m hose.

Smartbands were fitted on the leading edges on the pipe for added protection against tampering etc.

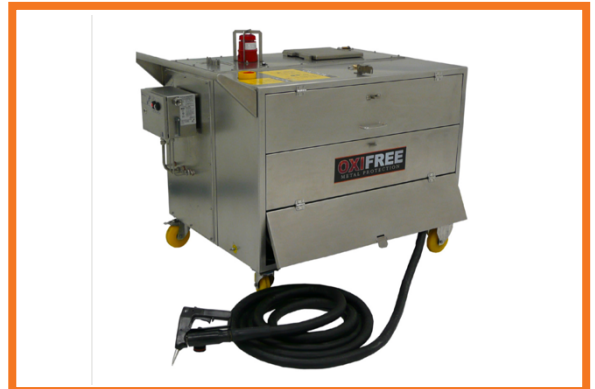
*Oxifree Polymelt 50 A-I (Atex & IECEx) Application Machine*

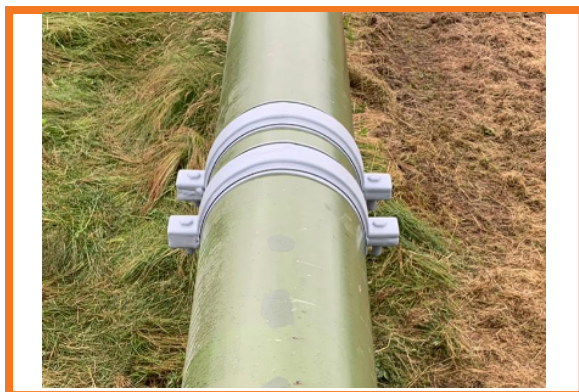
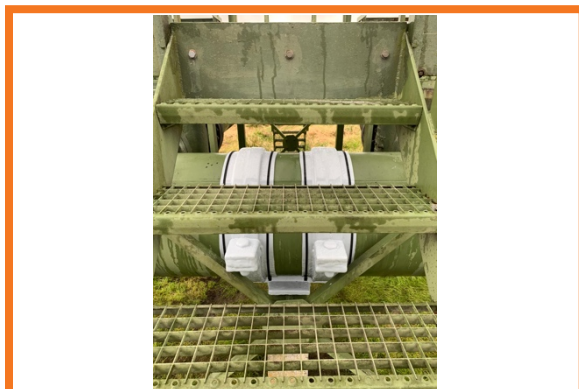
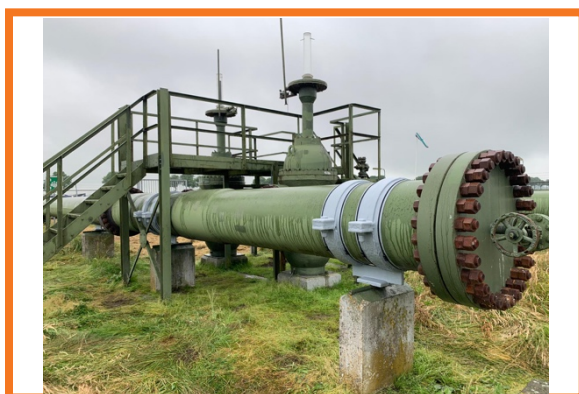
*Pipe Clamp Assembly Encapsulated by Oxifree TM198*
