## Fire Hydrant Corrosion Protection Case Study

## Fire Hydrant Corrosion Protection

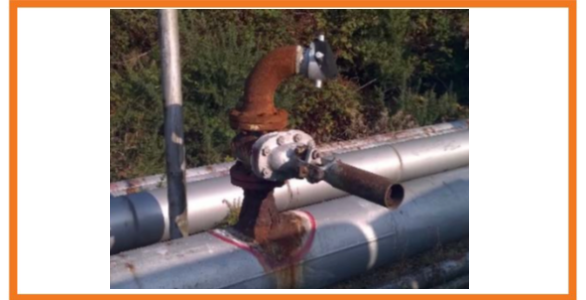
Hydrant prior to clean & application

Avon Valley Water requested Oxifree to provide a long term corrosion protection system to emergency fire hydrants around a petrochemical and chemical storage and production site within the Southampton area. The hydrants already showed signs of deterioration and a system was required to arrest further decay without shutdown of the vital components on the site safety system.

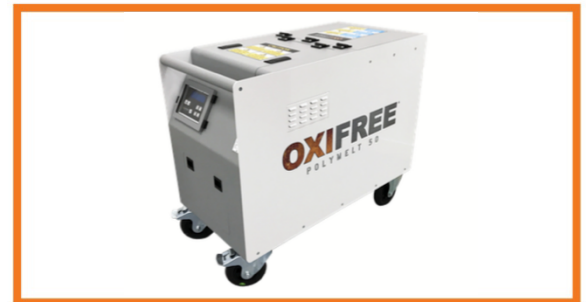
Polymelt 50 Application Machine

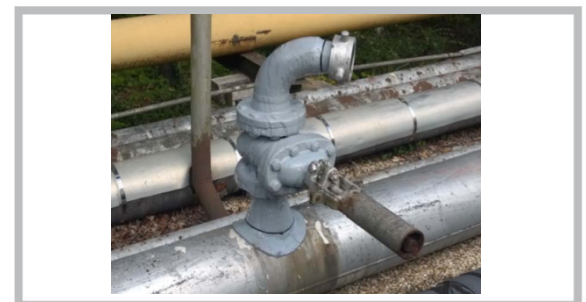
Hydrant after TM198 application

The 7 hydrants and interfaces were coated with a 4-6mm coating of Oxifree TM198 within a 7 hour window and involved coating of the entire hydrant (approx. 1.5m tall) and providing a coating to prevent any further degradation to the weld and hydrant interface of the emergency water pipe, ensuring the Oxifree coating offers long term protection to metallic parts, but also easy access to threaded sections of the hydrant and free rotation of the valve handle should use be required.
