# Preservation of Wellhead & Bolted Connections

## ***Preservation of wellhead & bolted connections for long term protection against corrosion***

| Location | France |
| Local Environment | Onshore Gas Storage |

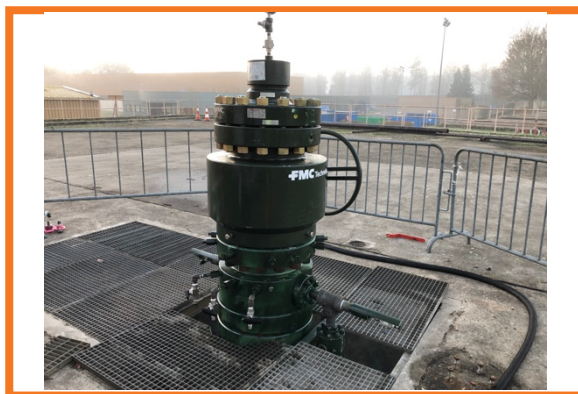
*Wellhead prior to coating with Oxifree TM198*

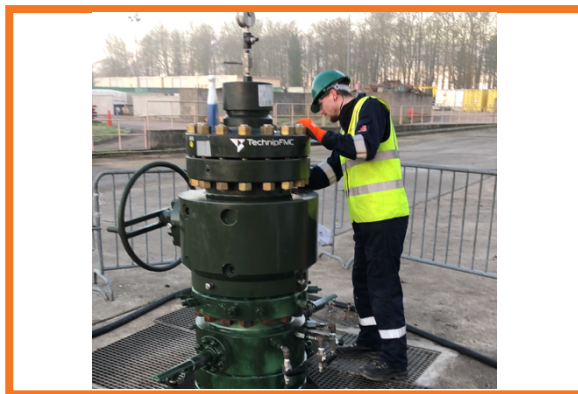
*Carrying out minimal surface preparation*

Following the minimal surface preparation (brushing loose corrosion away with a wire brush), 2 x 2mm coats of Oxifree TM198 were applied in sections on the wellhead working from the top downwards.

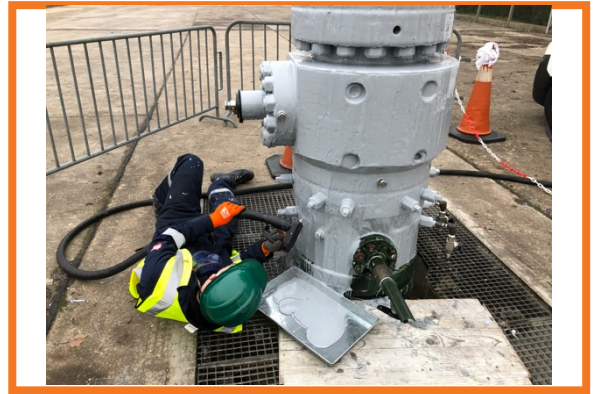
*Oxifree TM198 application taking place*

An Oxifree team consisting of a supervisor and an application technician completed the project in 2-days.  
The Oxifree TM198 was applied directly onto the wellhead per Oxifree application procedures.

The wellhead was coated using the Polymelt 50 unit and a 15-metre hose.

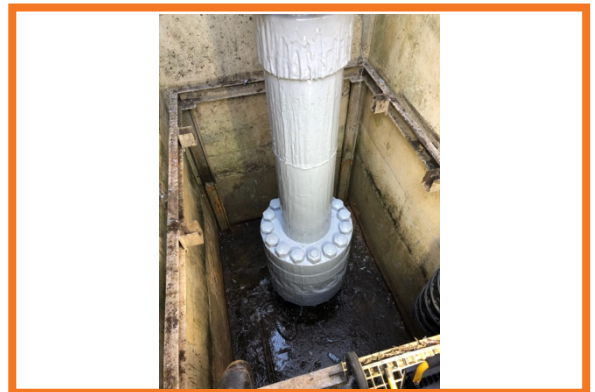
*Lower section of wellhead complete*

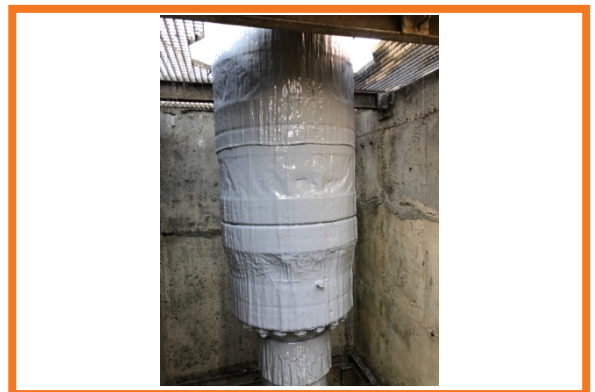
*Completed section of wellhead*

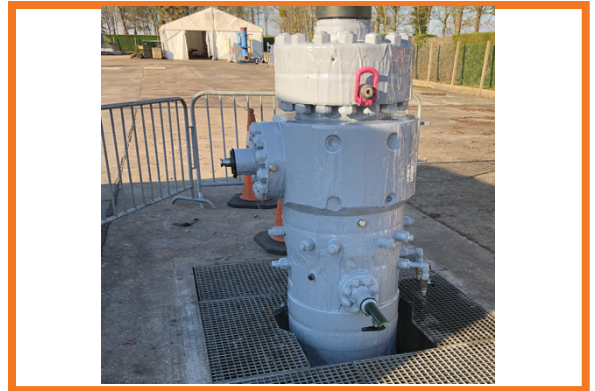
*Top section, washed down and still looking good*

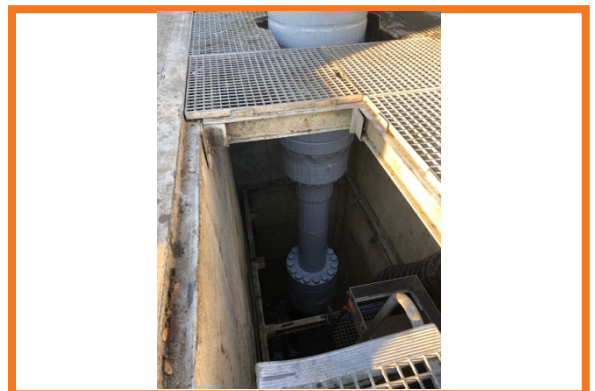
*Lower section, washed down and still looking*
