## Kick Pipe Protection – Naval Vessels

## Corrosion protection on deck kick pipes (naval vessel)

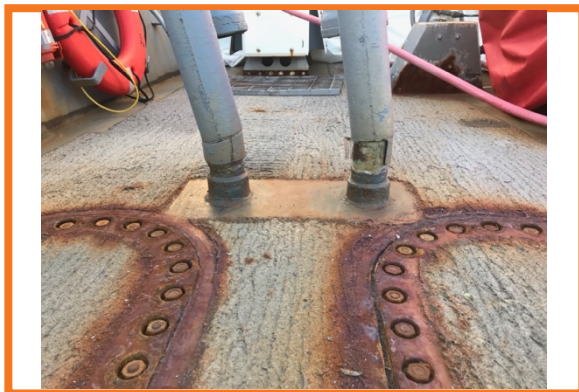
*Kick Pipes Prior To Coating*

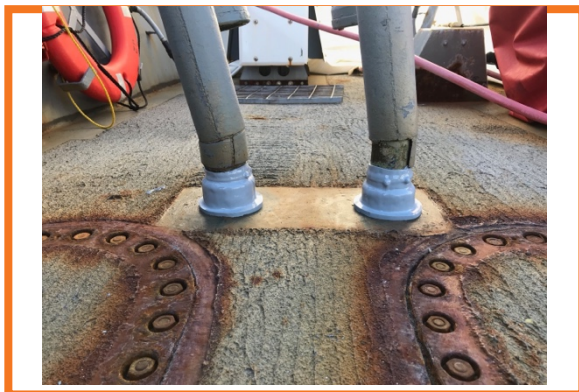
*Kick Pipes - Oxifree*

Oxifree application technicians completed the project in 5 days. The Oxifree TM198 was applied directly onto kickpipes all the way down to the deck to protect from water ingress. As a secondary measure, Oxitape was applied on top of the TM198 to allow for a mechanical barrier to avoid any damage to the TM198 during operations etc.

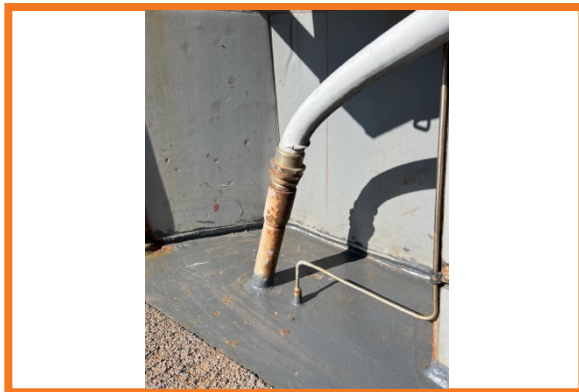
*Kick Pipe Prior To Coating*

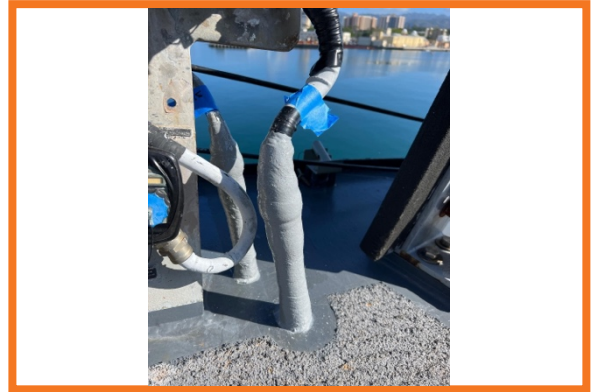
*Kick Pipes – Oxifree & Oxitape*

A 4mm coat was applied to all areas. The coating, as approved by the client, will ensure the kick pipes are protected for 10 years. No sand-blasting required, weather was not an issue during application. In the future, the material is easy to remove for inspection. The anti-corrosion oil also acts as a penetrating oil for any existing corrosion.

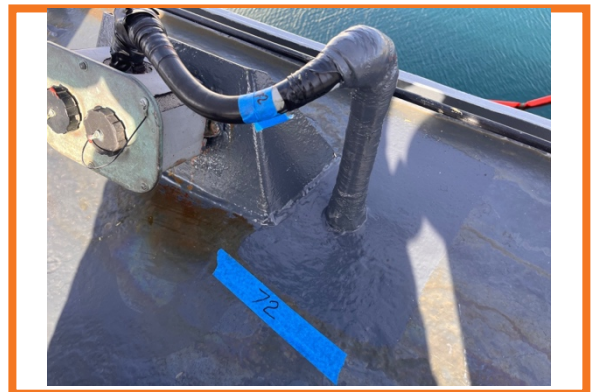
*Kick Pipe – Oxifree & Oxitape*

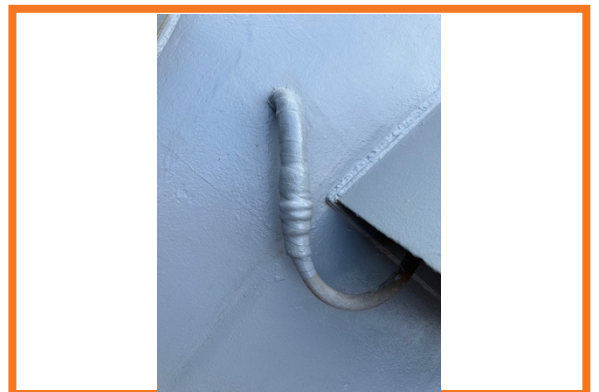
*Kick Pipe – Oxifree & Oxitape*
