# Life Asset Extension for Flanged Connections

## Case Study

| Location | Nigeria – Bonga FPSO |

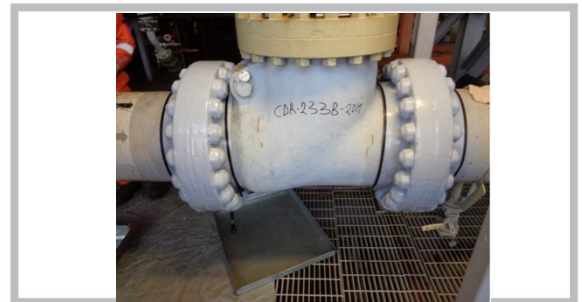
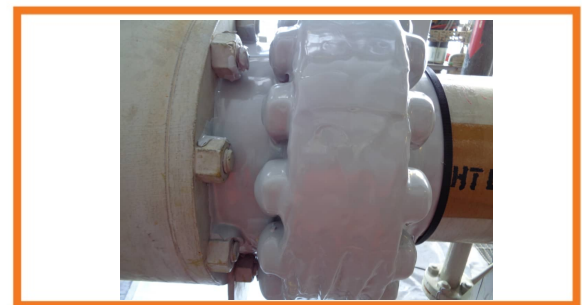
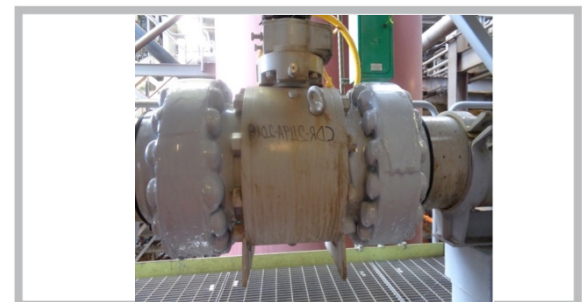
Romson Oilfield Services have been carrying out Oxifree TM198 application on flanged connections on the Bonga FPSO which were heavily corroded, due to salt and water exposure in offshore environment. After encapsulation with TM198 the flanges are completely protected from any further corrosion damage caused by the harsh offshore environment.

The vessel has been regularly maintained using blasting and painting methods. However, there was persistent corrosion, especially on complex geometric areas such as flanges.

Before the application, the areas were cleaned with a wire brush (St 2) to prepare the surface, removing any loose rust flakes.

The coating has built-in corrosion inhibitor oil which exudes from the material and immediately stops further corrosion. It can be removed easily using a cutter or a knife for maintenance and inspection purposes.

The flanges were successfully coated, offering immediate and long lasting protection on the salt spray exposed substrates. Oxifree Anti -Corrosion Thermoplastic (ACT) coating is deemed to be the best solution to address the corrosion effectively.
